Asbestos Survey at

*Muswell Hill Library
Queens Avenue
London
N10 3PE*

<i>SiteID:</i>	5279-001
<i>Survey Ref:</i>	5279-001
<i>Last Survey:</i>	14 March 2005
<i>Printed on:</i>	04 April 2005
<i>Title Section</i>	Page 1 of 2

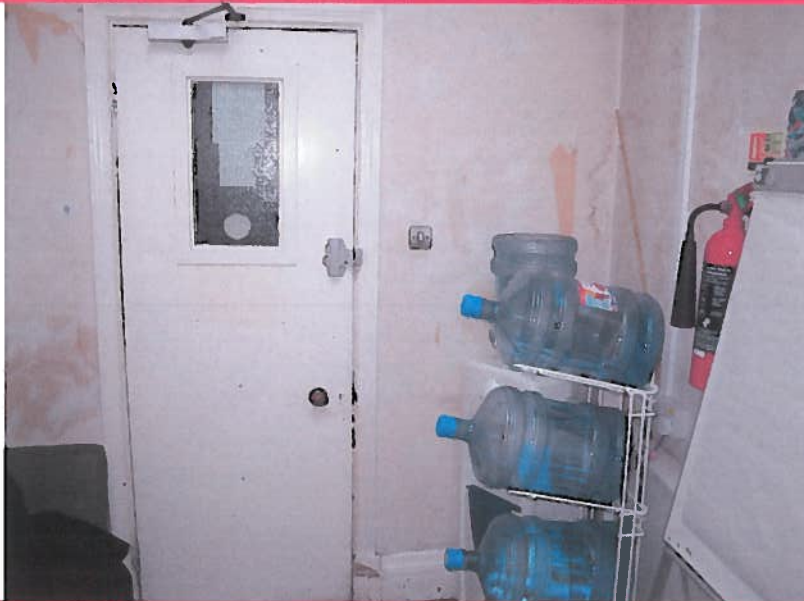
5279-001-BS01

Panel lining to back of door (Also present in other areas - see drawing)

Item / Material	Board			Hazard Band	C	Material Assessment Score	<u>5</u>
Product Type	Score	Extent of Damage	Score	Surface Treatment	Score	Asbestos Type	Score
AIB	2	Good Condition	0	AIB-Encapsulated	1	Amosite/Chrysotile	2

Hazard Warning Level Low Hazard Material

Surveyors Comment Label and monitor for deterioration or remove under fully controlled conditions

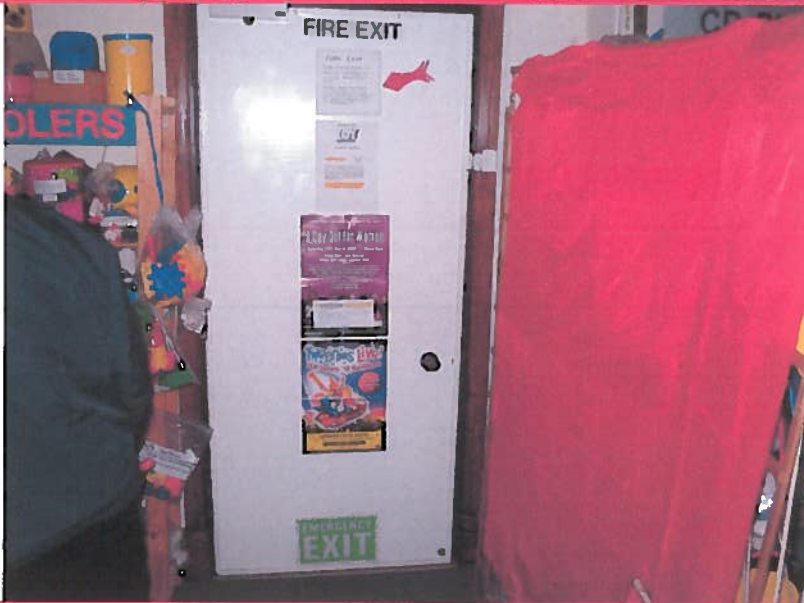
Building Main	Floor 1st Floor	Inspection Ref No 5279-001-BS02
Room Toy Library	Area Door

Panel lining to back of door

Item / Material	Board		Hazard Band	C	Material Assessment Score	5	
Product Type	Score	Extent of Damage	Score	Surface Treatment	Score	Asbestos Type	Score
AIB	2	Good Condition	0	AIB-Encapsulated	1	Amosite/Chrysotile	2

Hazard Warning Level Low Hazard Material

Surveyors Comment Label and monitor for deterioration or remove under fully controlled conditions

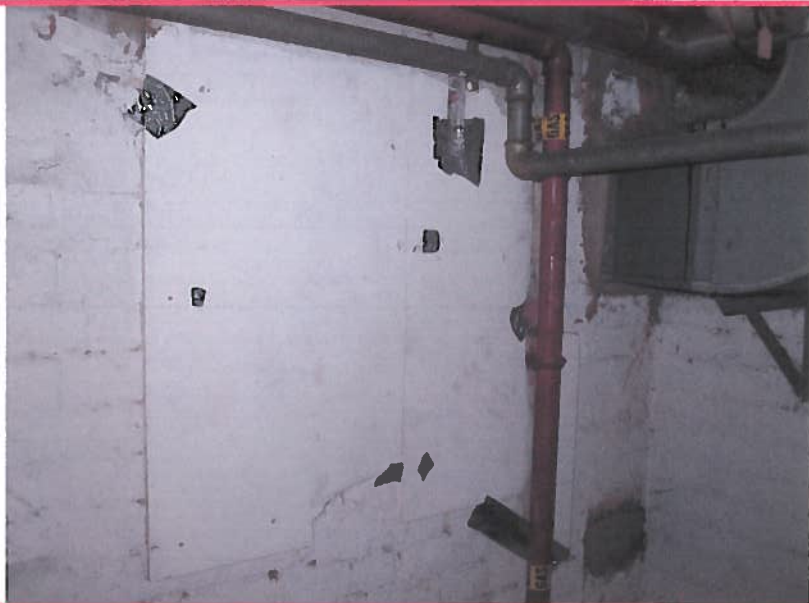
<i>Sample Ref</i>	<i>Description/Remarks</i>	<i>Surveyor's Comment</i>	<i>Action Date</i>
Main Boiler Room	Basement Wall	5279-001-BS03	Panel on wall to back of dumb waiter	Encapsulate, label and monitor for deterioration or remove under fully controlled conditions	20/03/2006

Item / Material	Board			Hazard Band	B	Material Assessment Score	7
Product Type	Score	Extent of Damage	Score	Surface Treatment	Score	Asbestos Type	Score
AIB	2	Medium Damage	2	AIB-Encapsulated	1	Amosite/Chrysotile	2

Hazard Warning Level Med Hazard Material

Surveyors Comment Encapsulate, label and monitor for deterioration or remove under fully controlled conditions

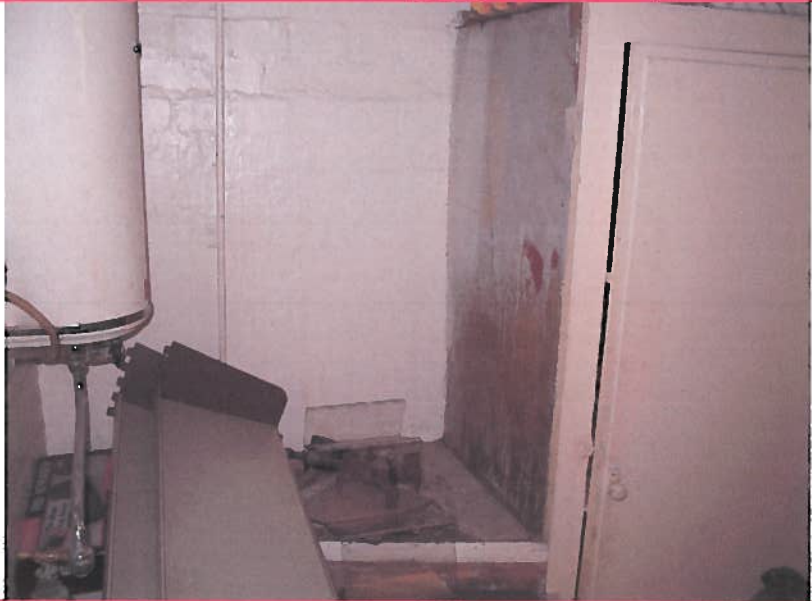
5279-001-BS04

Board lining to 2No. shelves and side of cupboard

Item / Material	Board		Hazard Band	D	Material Assessment Score	4	
Product Type	Score	Extent of Damage	Score	Surface Treatment	Score	Asbestos Type	Score
Asbestos cement	1	Low Damage	1	Asbestos cement- Unsealed	1	Chrysotile	1
Hazard Warning Level	Minor Hazard Material						
Surveyors Comment	Encapsulate, label and monitor for deterioration or remove under fully controlled condition

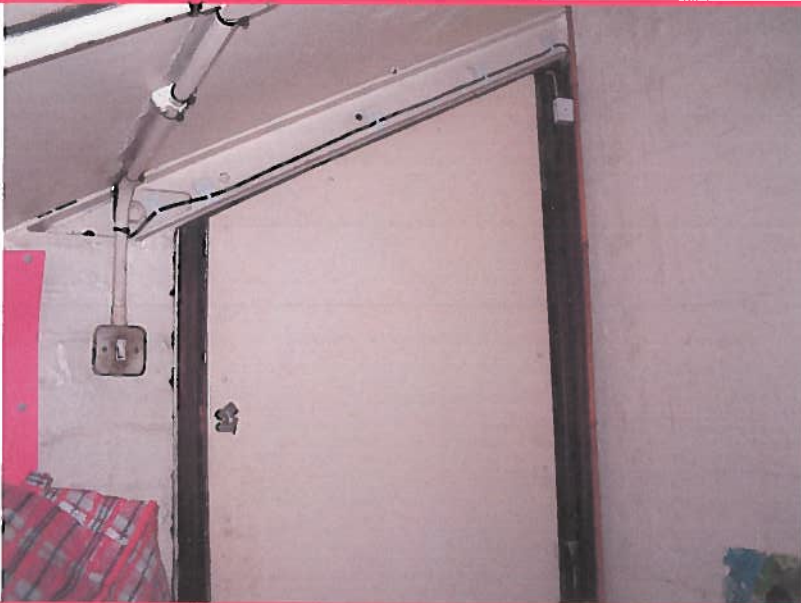
Door

Low Damage

Low Hazard Material

Encapsulate, label and monitor for deterioration or remove under fully controlled conditions
