## **Feasibility Report**

**Adaptation and  
Transformation Works**

**Muswell Hill Library**

**Haringey Council**

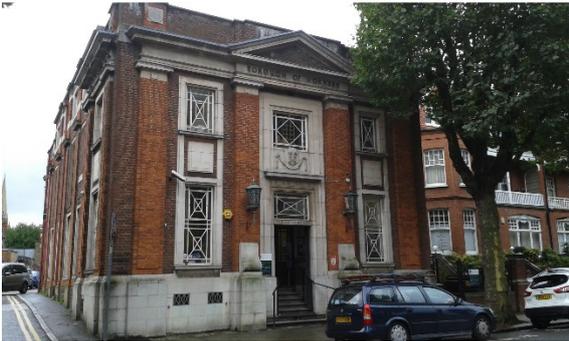
Photo 01 – North (Main) elevation & main entrance

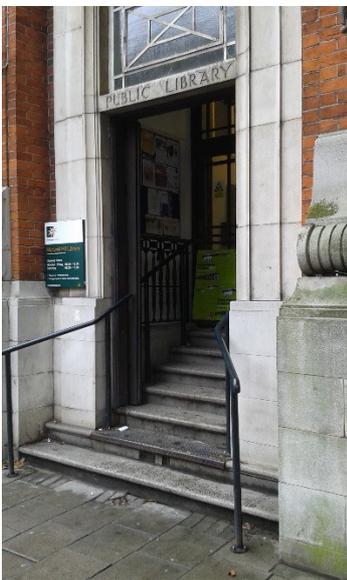
Photo 03  
Stepped Main Entrance

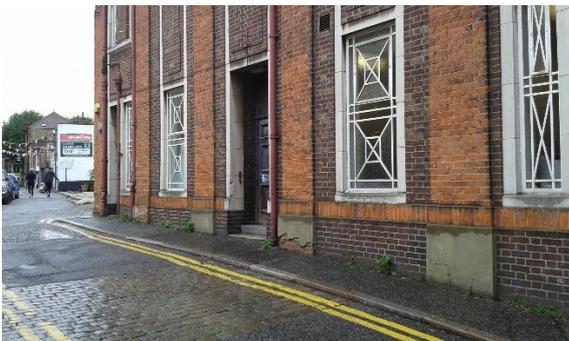
Photo 06 – East (side) elevation, narrow footpath  
Stepped access/emergency exits

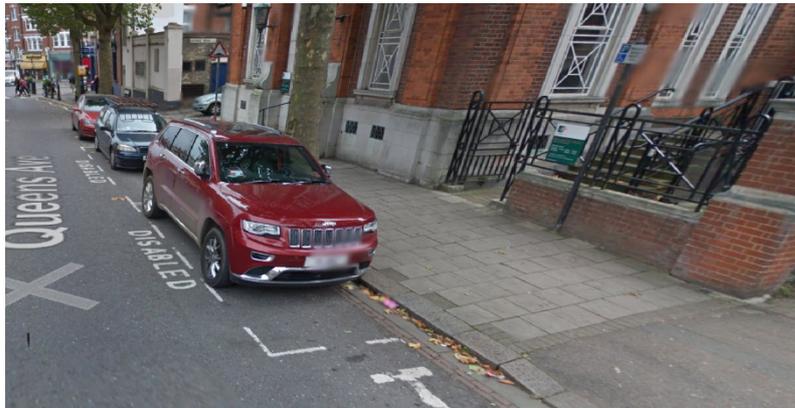
Photo 34 – Disabled Parking & Pedestrian Footpath located on Queens Ave

It should be noted that whilst 2 designated disabled spaces have been provided, these are not compliant under current legislation due to lack of set down and safe access zones.

As a very minimum consideration, our recommendation would be to form a new external entrance at ground floor level which is compliant with current legislation, and to install a new canopy to provide a sheltered approach and use of the existing platform lift.

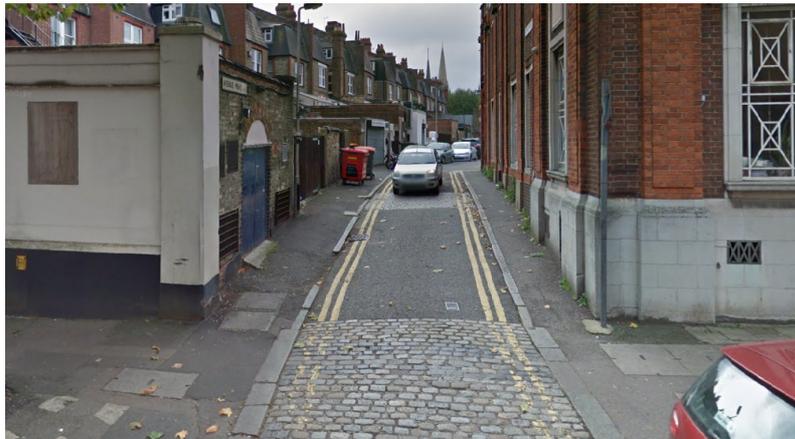
Photo 35 – Ave Mews at access point via Queens Ave

The pedestrian footpath (shown on left hand side of road in photo above), is generally 1.8 metres wide, but has a number of drop kerb sections for access to the gated rear driveways and courtyards of the Muswell Hill Broadway properties. It has been observed that this footpath is largely obstructed by numerous large wheeled waste collection bins, which prohibits safe pedestrian use.

The pedestrian footpath (shown on right hand side of road in photo above) has a maximum width of 1.2 metres, reducing to between 1-1.1 metres wide where stone column details are located at regular 3 metre centres. There is a drop of between 30-80mm between the footpath and road surfaces. The surface level of the footpath raises by approximately 800mm over the full length of the side elevation, which equates to a gradient of lesser than 1:20, which is satisfactory under current legislation.

The single lane vehicular access road is 3.5 metre wide and is used for vehicles going in both directions. The road widens slightly in line with the vacant land to the rear of the library. It has been observed that there is insufficient width for vehicles to pass one another which therefore means that in the event of two cars meeting, it is necessary for one to mount the pedestrian footpath or vacant land to enable the other to pass. This again prohibits safe pedestrian use.

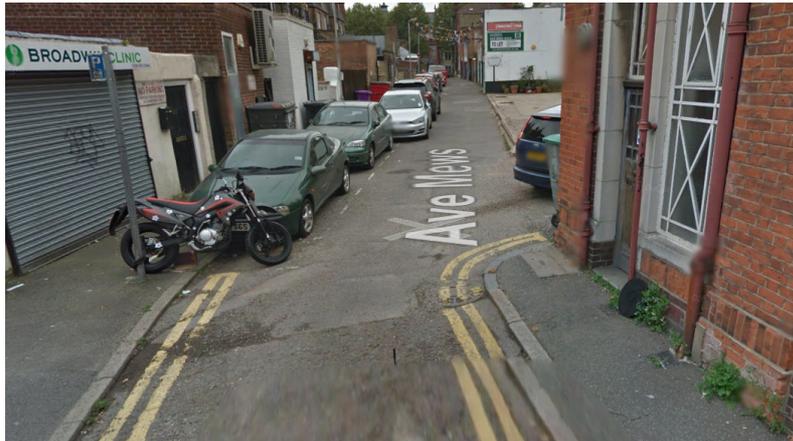
Photo 36 – Ave Mews at rear of library

We have reviewed the use of the pedestrian footpath running directly alongside the library in line with current British Standards legislation document BS8300:2009+A1:2010 Design of buildings and their approaches to meet the needs of disabled people - Code of practice, and in particular, Section 5 Access routes to and around buildings, Item 5.2 Width and height of an access route.

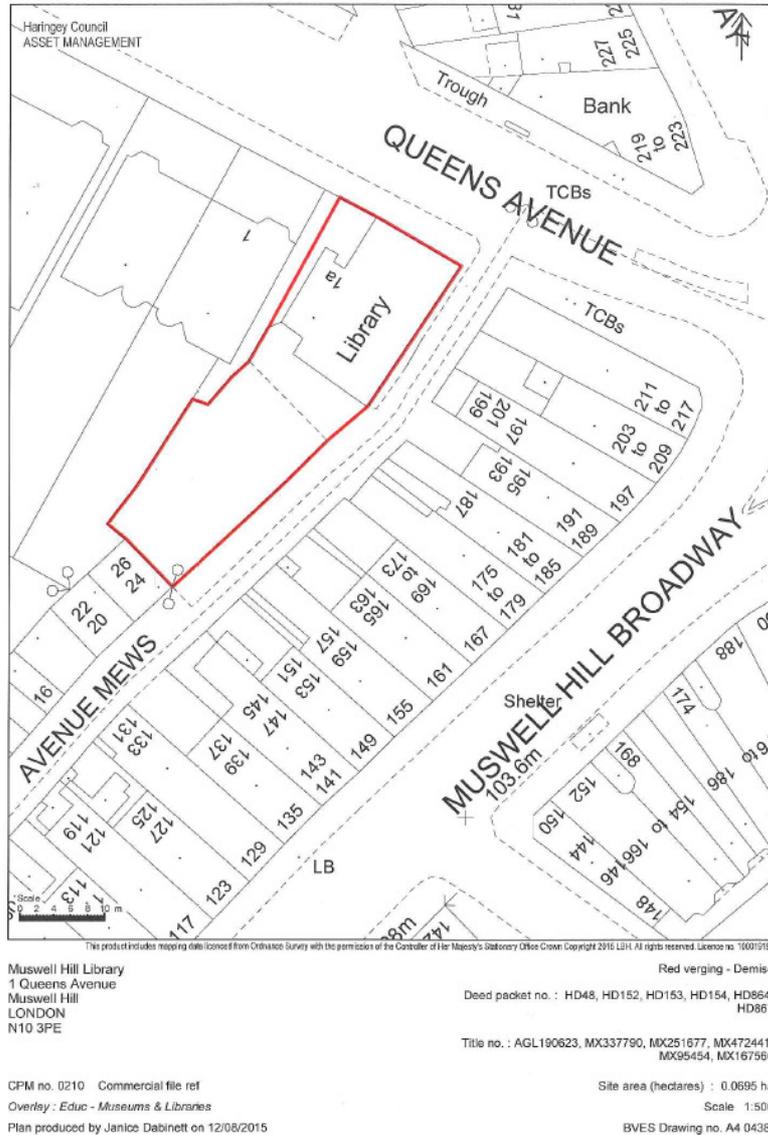
**9.01 Asset Management Site Plan 1:500 (12th August 2015)**

The land owned by Haringey Council is clearly defined by the red line. The Library building is located in the northern section of the plot with direct access onto both Queens Avenue and Avenue Mews.

The remainder of the plot, which is approximately 400m<sup>2</sup> in size, is a concrete hard standing, slightly raised up from road level which is currently used sparingly as a car parking facility. It is our expectancy that the section of land to the south of the Library would be much sought after for development given its central location within the Muswell Hill area.
