TREES

TREE SURVEY

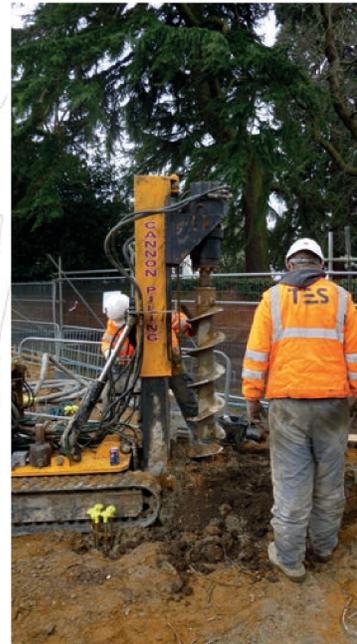
Building over tree roots – where branches construct a large piling rig, a mini-piling rig is used

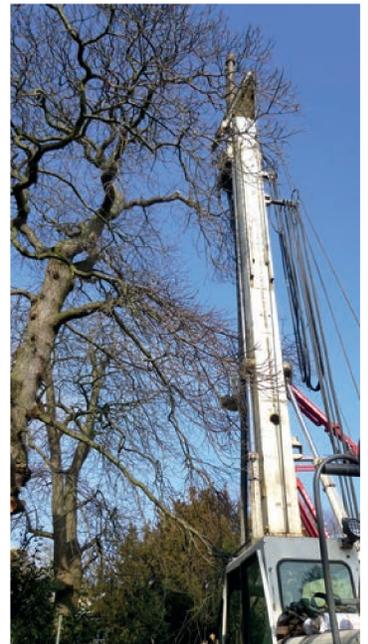
Building over tree roots – extreme care is needed to avoid the piling rig damaging the tree crown

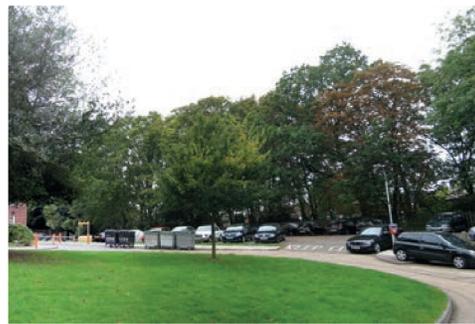
AREA 1

The proposed block extends minimally into the RPA of three trees: less than 5% of the RPA of one tree and less than 1% of the RPAs of two other trees. The crowns of trees in the SINC would need cutting back to provide clearance from the building. Specific pruning proposals need to be assessed for each tree to minimise impacts on tree health and appearance.

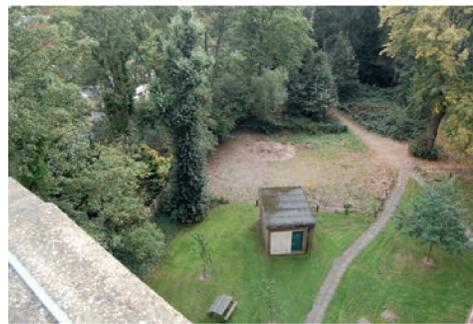
AREA 2

The proposed block would require the removal of: a small dead Rowan sapling; a mature Lime tree; and part of a small group of Holly trees. The Lime tree is considered to be in poor condition because of decay, but is also a potential bat roost. The block extends minimally (less than 1%) into the RPA of a nearby Category A tree (Lime T74). The crowns of trees in the SINC would need cutting back to provide clearance from the building.

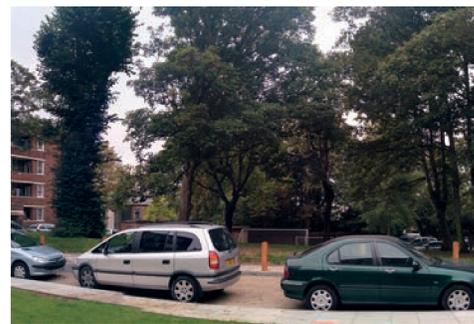
AREA 3

The proposed block would require the removal of: two sapling trees, two Pear trees, a Sycamore and a Lime tree. The Lime tree is considered to be in poor condition because of decay, but is also a potential bat roost. The block extends minimally (less than 1%) into the RPA of one other (off-site) tree. The crowns of adjacent trees would need cutting back to provide clearance from the building.

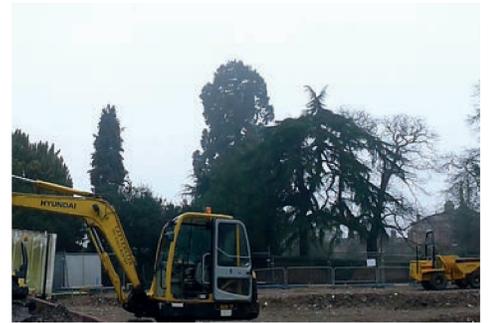
Building over tree roots – the piling mat is on levels to avoid cutting roots

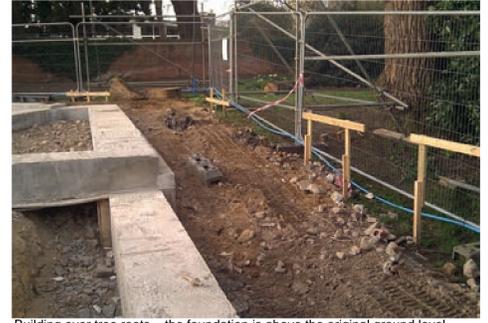
Building over tree roots – the foundation is above the original ground level, bridging over the tree roots

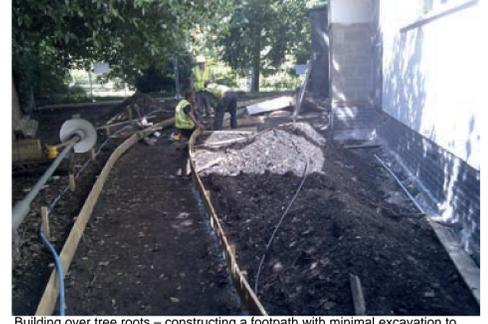
Building over tree roots – constructing a footpath with minimal excavation to avoid cutting roots

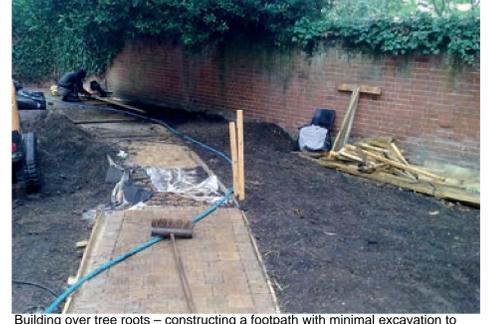
Building over tree roots – constructing a footpath with minimal excavation to avoid cutting roots

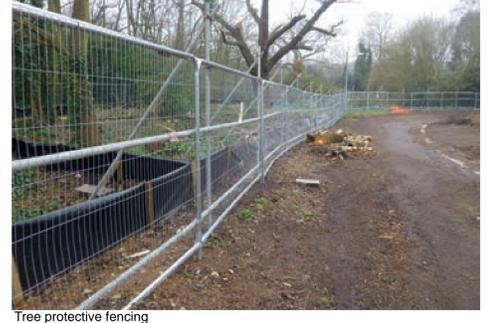
Tree protective fencing

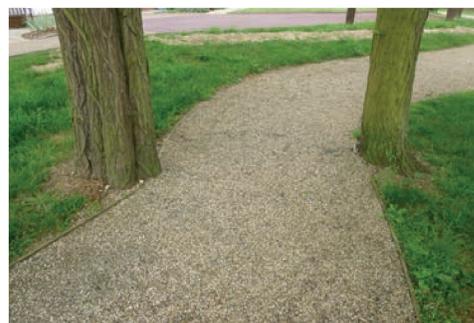
Reduced-dig surfaces

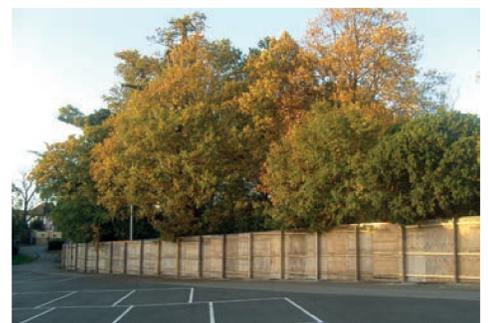
Tree protective fencing
